Environmental Analyses of Industrial Waste using Satellites and On-site Sensors

Wenhui ZHAO*, Takanori SASAKI** and Shigetaka FUJITA***

Key Words : Environmental analyses, Industrial waste, Remote sensing, Topographic analysis

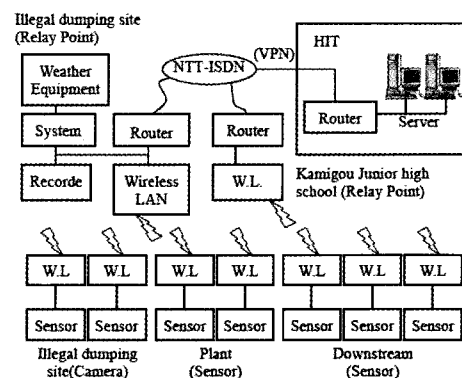
Figure 1 shows the on-site observation system for reception,

Figure 1: On-site observation system

processing and analysis of the data from on-site sensors. Five water quality analyzers, weather measuring equipment and two infrared cameras were set up at the dumping site. Data was then transmitted to the monitoring PC in the university every three minutes. The items measured were pH, electric conductivity, temperature, flow rate, wind direction, wind velocity, air temperature, and precipitation. This system and field work was used to back up the satellite images for better accuracy.

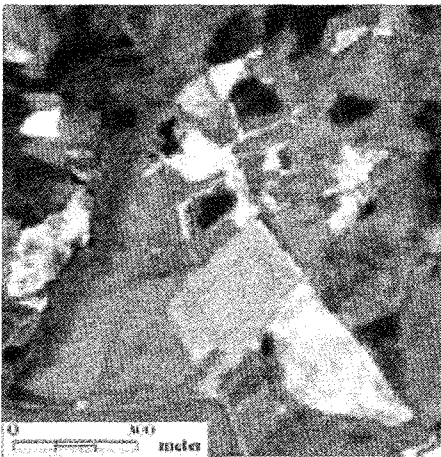
The Figure 2 is the output image, which is a false color infrared photograph. Bright red areas on the image represent high infrared reflectance, corresponding to healthy vegetation, either under cultivation, or along rivers. Slightly darker red areas typically represent native vegetation such as shrub and grassland. In this case, the scale of red areas is much less than other areas, meaning that there was less on-site vegetation than in the surrounding area. Moreover, by Comparing with the SPOT2 image for 1992 (Figure 3), we are able to find decrease in the amount of vegetation and determine those areas that had changed in that period.

Figure 2: Fused image from a multispectral image and a panchromatic image

Two SPOT images were fused to improve the presentation by using HSV Sharpening. The result was a color composite image of enhanced spatial resolution. The scale of green vegetation was shown in this false color infrared photograph. We can find decrease in the amount of vegetation and determine those areas that had changed in that period by comparing images that were recorded in different years. The three-dimensional visualization of the site was combined using DEM data and Quikbird data, and each pixel of the DEM data were classified into terrain types by topographic analysis. The changes of water quality were analyzed on pH and electric conductivity. In our view, pollution in the site still doesn't diffuse and the water quality is improving little by little because of the water purification plant and the removal of waste. But it is needed to more repair remove the waste. In the future, new satellite data and ground data will be sequentially collected by this system. This will be compared with current data to understand and forecast environmental changes.

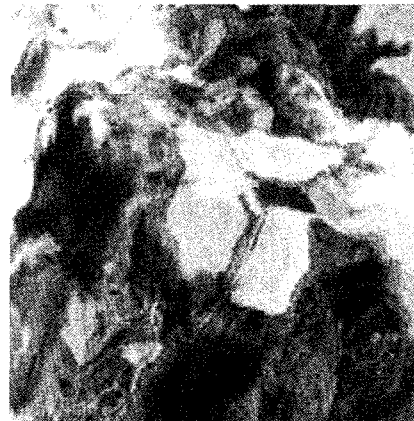
The DEM data consists of a sampled array of elevations for a number of ground positions at regularly spaced intervals^[4]. The DEM data of 15 m spatial resolution on the site was combined with a Quickbird image of 2.4 m spatial resolution to obtain high spatial resolution. The output image is a three-dimensional visualization of the site and its surrounding areas, and it is shown in Figure 4. In addition, the elevation of the site is about 440 m.

Figure 4: Three-dimensional visualization by combining the DEM data with Quickbird data

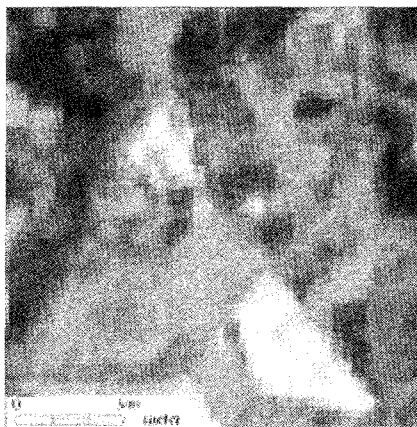
Figure 3: SPOT2 image for 1992

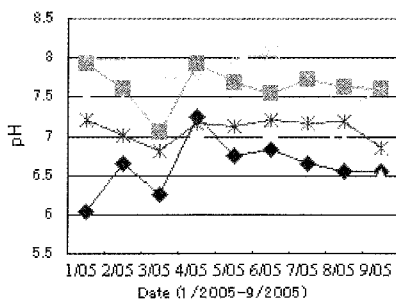
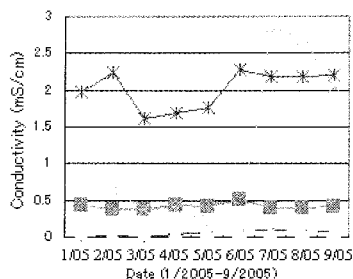
a: Changes of pH

b: Changes of electric conductivity

Figure 7: Changes of water quality

Figure 7 shows the changes of water quality on pH and electric conductivity from January, 2005 to September, 2005. In this figure, pH and electric conductivity of the water on the site (Point 4) were higher than normal water (Point 1 and Point 3), e.g. the mean pH value of Point 4 from January, 2005 to September, 2005 was about 7.78, while that of Point 3 was near 7. The water purification plant was established to purify the polluted water. Electric conductivity value of Point 5 was high because of chemicals, while the pH of that reduced to about 7. On the other hand, data of its surrounding areas (Point 1 and Point 3) was similar to those of the normal water. So for the moment, pollution still didn't diffuse.

Although the electric conductivity value of Point 4 surged violently in this period, the pH value reduced to some extent. This should be due to the water purification plant and the removal of waste. The water purification plant was changed from old one to new one in July, 2005. At the same time, the sensor on Point 4 was reset. The removal began from November, 2004, and 30,552 tons of waste (22,792 tons of solid waste and 7,760 tons of fluid waste) was removed until September, 2005. But, only 4.56 percent of waste in Aomori Prefecture was removed. It is needed to remove the waste more quickly.
